ADHESION ON PRE-TREATED CONTAINERS

PDS International – Peter Kiddell

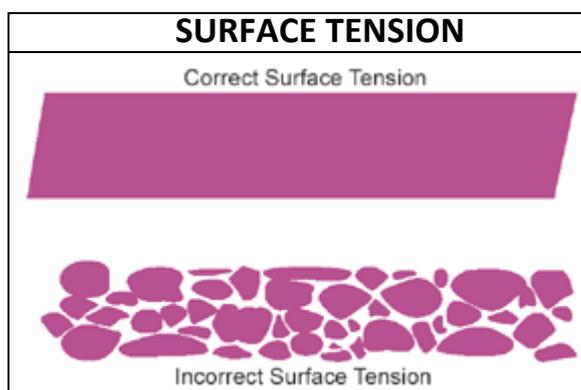
Whichever printing process we are using handling the surface to be printed can cause havoc with the print. Ink will only adhere to a substrate if the surface energy of the surface is higher than the surface tension of the ink.
